TECHNICAL REPORT EL-90-14

# HYDRAULIC AND ENVIRONMENTAL EFFECTS OF CHANNEL STABILIZATION TWENTYMILE CREEK, MISSISSIPPI

December 1990

Prepared for US Army Engineer District, Mobile  
Mobile, Alabama 36628-2288

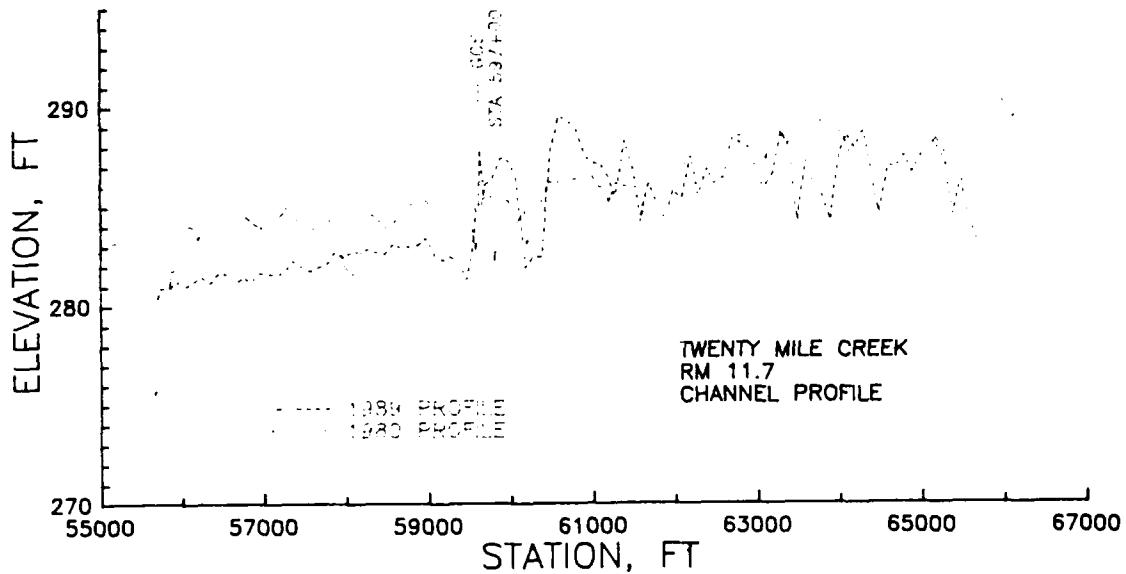
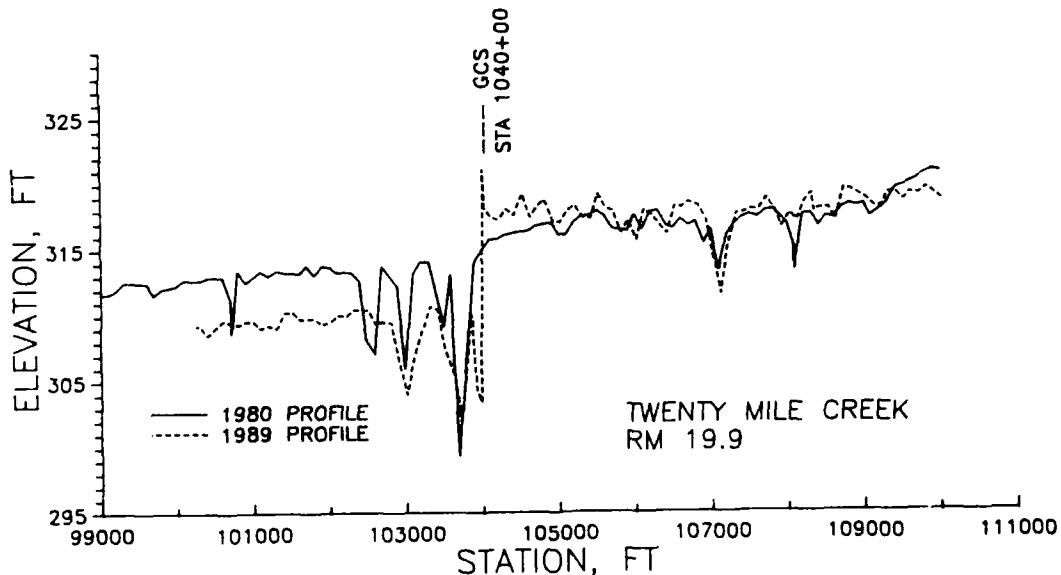
50. The detailed 1989 thalweg survey upstream and downstream of the GCS at RM 19.9 and corresponding portions of the 1980 survey are shown in Figure 14b. The headcut that existed at the time of the 1980 survey (prior to construction of the structure in 1982) is clearly visible. The headcut

remained stationary but significant degradation (approximately 5 ft) occurred in the downstream reach. A study of 1981 and 1985 aerial photography confirmed that the headcut had remained stationary. However, since the GCS was constructed on an outcrop of erosion-resistant material which functioned as a geologic control it would be incorrect to assume that the GCS was solely responsible for stopping the headcut. The slope of the bed in the downstream reach was 0.004, and the difference in thalweg elevation across the GCS was 8 ft. Aerial photography also indicated another headcut site about 7,000 ft downstream from RM 19.9, near the downstream end of the degraded reach, and it appeared to function as a hydraulic control that influenced the flow conditions upstream to the GCS. Moreover, there was no visible movement of the headcut during the period between the aerial photos. The lack of headcuts and subsequent movement thereof as observed on aerial photos indicates that most of the channel degradation occurred as general bed scour. Upstream of the structure, aggradation was apparently induced by the GCS for a distance of approximately 5,000 ft.

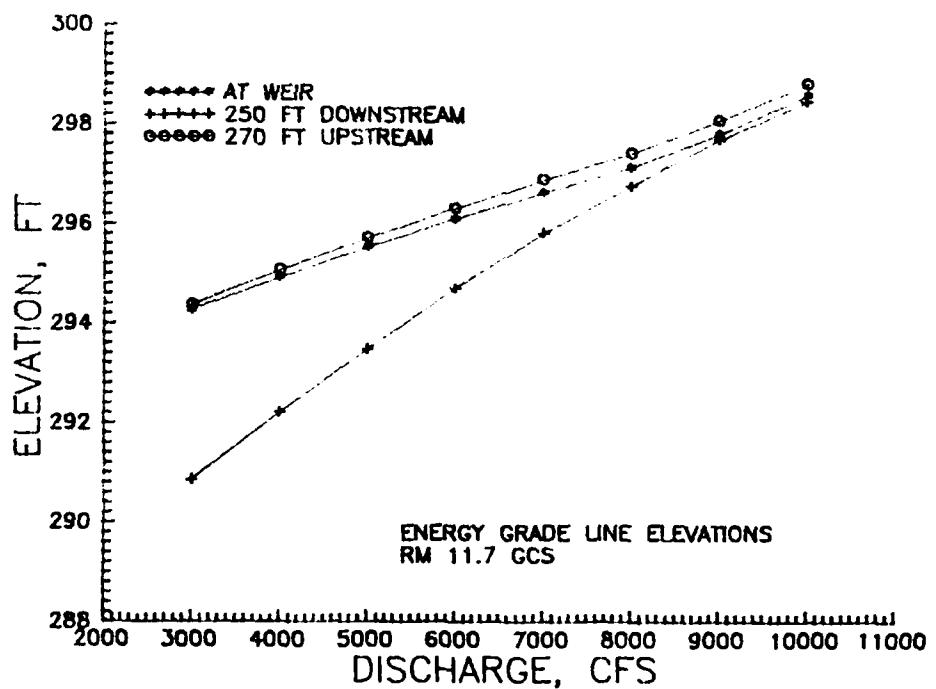
52. Figures 15a and 15b show the results for the GCS at RM 11.7 where the three sections were 250 ft downstream of the weir, at the weir, and 270 ft upstream of the weir. Figure 15a shows that the water surface elevation at the upstream section is only slightly higher (0.4 ft) than the downstream section elevation at a discharge of approximately 8,000 cfs. Above a discharge of about 6,000 cfs, the water surface elevation at the weir is lower than at either the upstream or downstream section due to the flow accelerating over the raised bottom of the weir. Figure 15b is a plot of the energy grade line elevations and shows that at discharges above 8,000 cfs, the energy loss

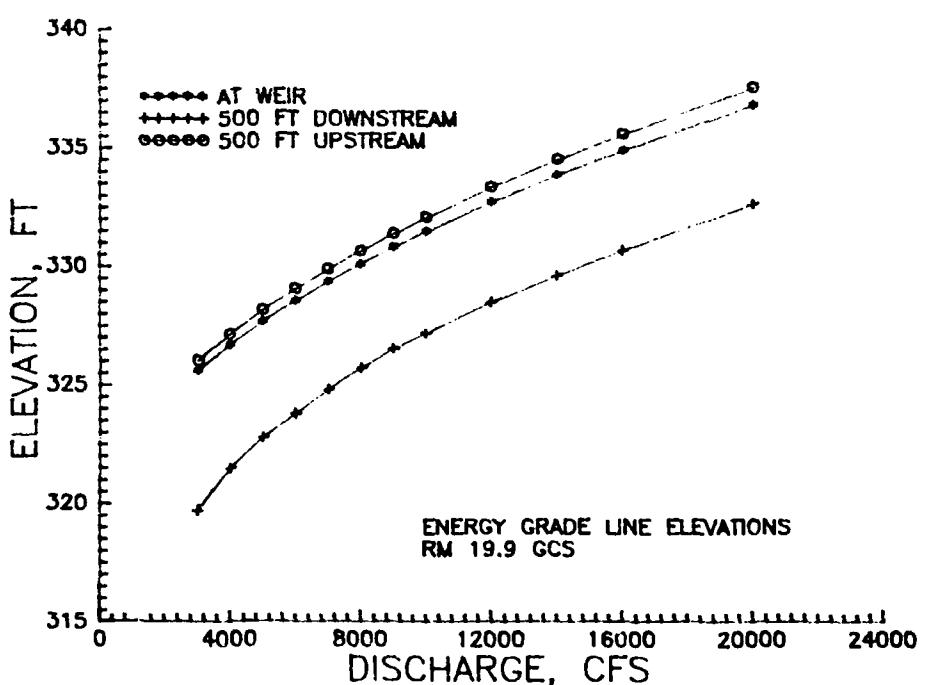
53. Figures 16a and 16b are similar plots for the GCS at RM 19.9 where the upstream and downstream cross sections were 500 ft from the weir. Figure 16a shows that the downstream water surface elevation was over 4 ft below the upstream surface elevation for discharges up to 20,000 cfs. Also, Figure 16b shows that the energy loss across the structure was over 5 ft at discharges up to 20,000 cfs, indicating that the structure functions as a hydraulic control for even the very high discharges. However, this is not surprising because of the significant degradation in the downstream channel and the large difference in thalweg elevation upstream and downstream of the structure (8 ft).

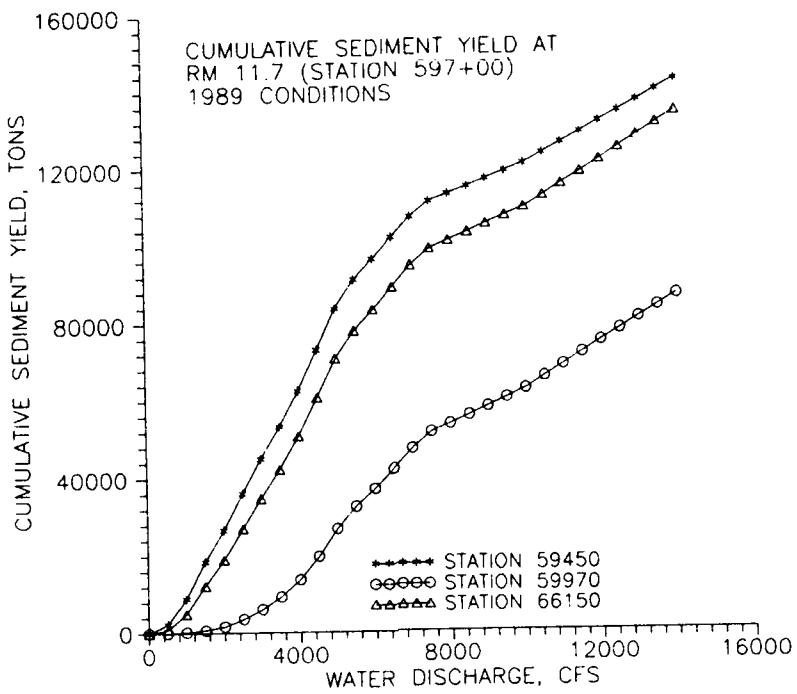
Figure 20. Cumulative annual sediment yield near RM 11.7 GCS (GCS weir is located at station 597+00)

yield curves (at all three cross sections) break and decrease between mean daily discharges of 7,000 to 8,000 cfs. Furthermore, the cumulative sediment yield below 8,000 cfs is between 70 and 80 percent of the total annual sediment yield in the downstream and upstream sections. Therefore, it appears that the mean daily discharges that have a long-term channel-forming effect on the channel are below 8,000 cfs.

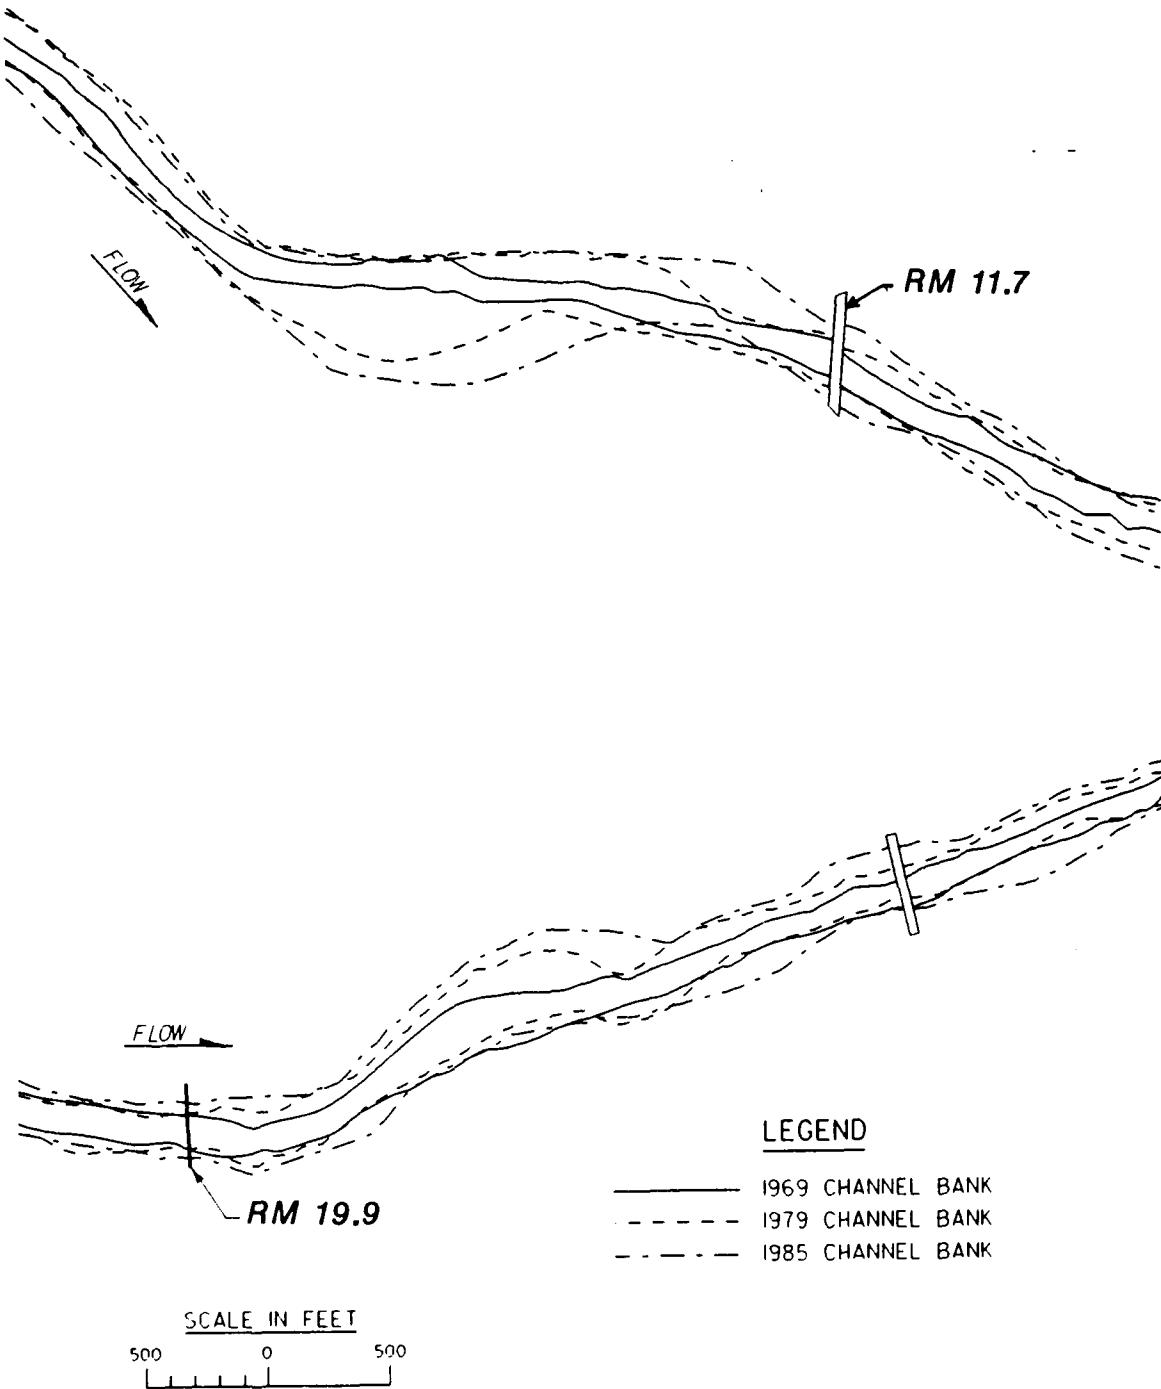
Figure 25. Bank lines in vicinity of RM 11.7 and 19.9 for 1969, 1979, and 1985

been removed from the banks, and bank erosion was evident. Upstream of the bridge, vegetation was still intact and the banks appeared stable. In the vicinity of RM 19.9 the 1969 photos showed that the channel was small with little vegetation on the banks but there was no apparent instability such as scour holes. The 1979 photos indicated that the channel was beginning to meander in the vicinity of RM 11.7 and a low-flow channel was beginning to form on the outside of the bends. A similar increase in channel meandering was indicated at RM 19.9 and the large scour hole indicated the hydraulic control at RM 19.9. A similar control point was noted several thousand feet downstream.
